## **Evaluation of Expedient Methods for Mitigating Dust on Helipads**

Jeb S. Tingle, Andrew Harrison, and John F. Rushing

September 2004

Final report

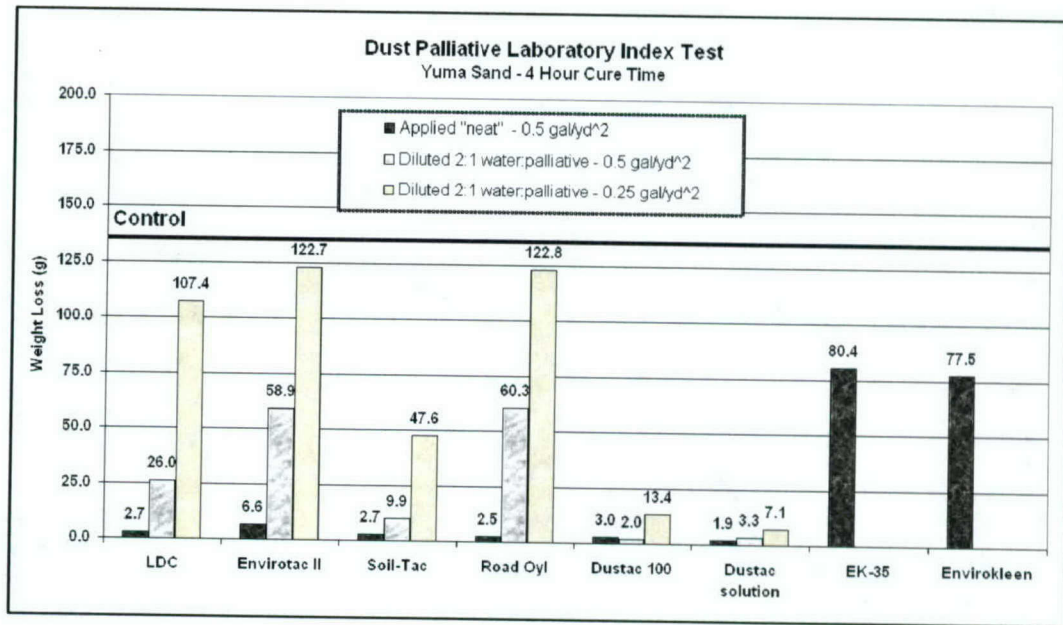
Figure 2. Air impingement results for 4-hr cured commercial palliatives

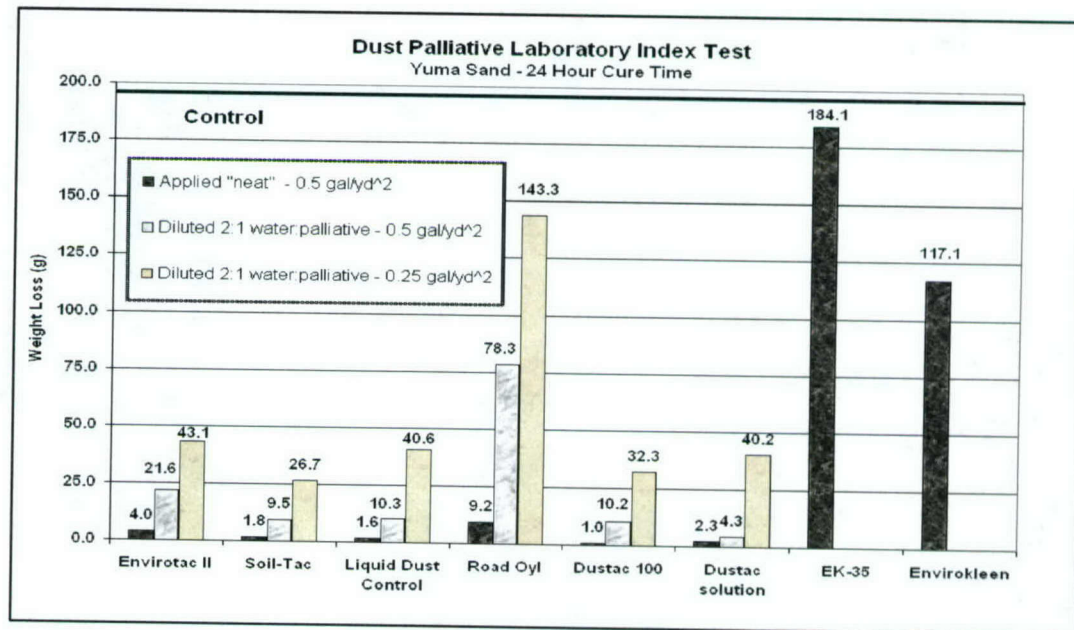
Figure 3. Air impingement results for 24-hr cured commercial palliatives

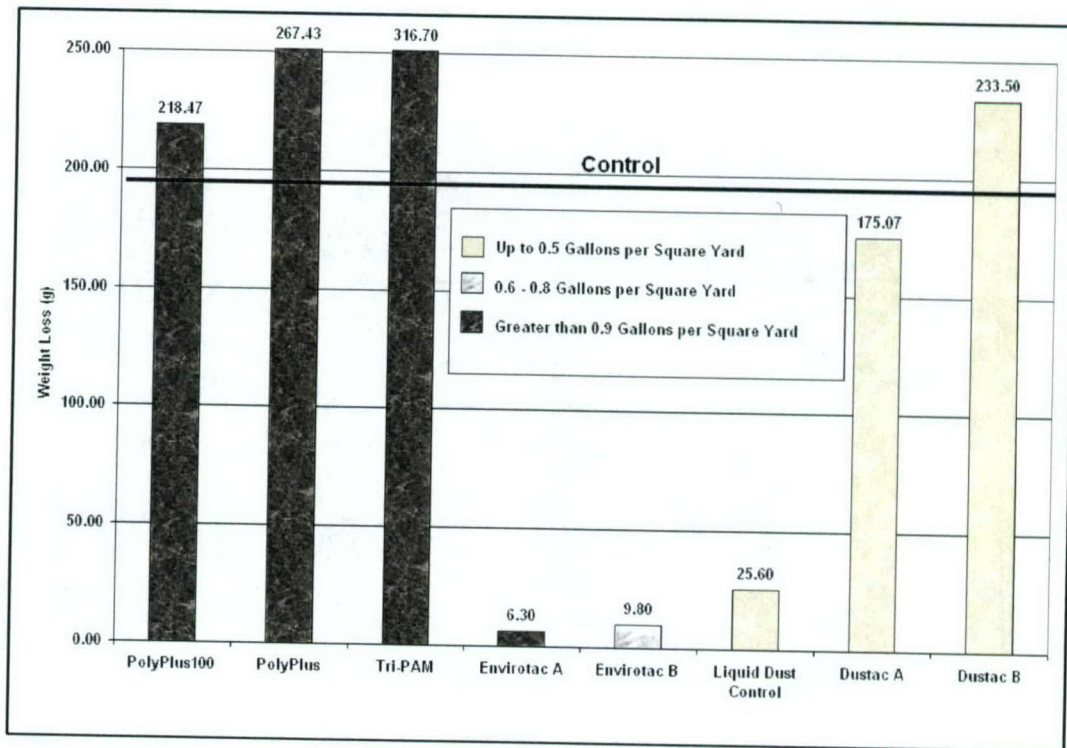
Figure 6. Air impingement results for 24-hr cured palliatives used at MCAS Yuma

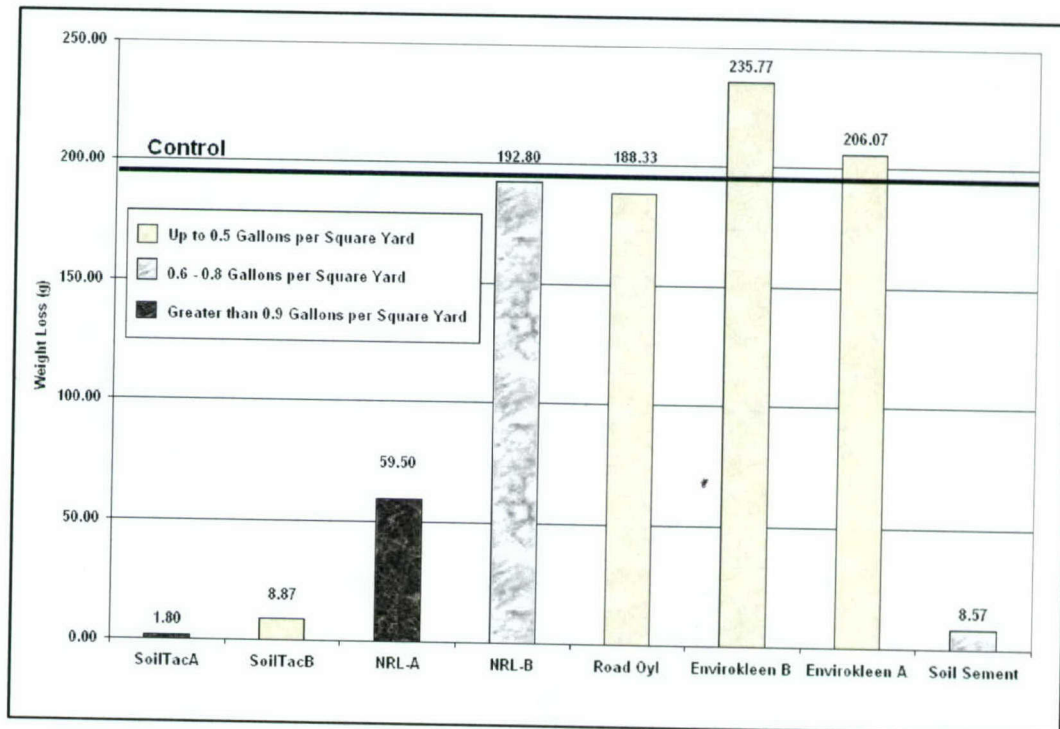
Figure 7. Air impingement results for 24-hour cured palliatives used at MCAS Yuma

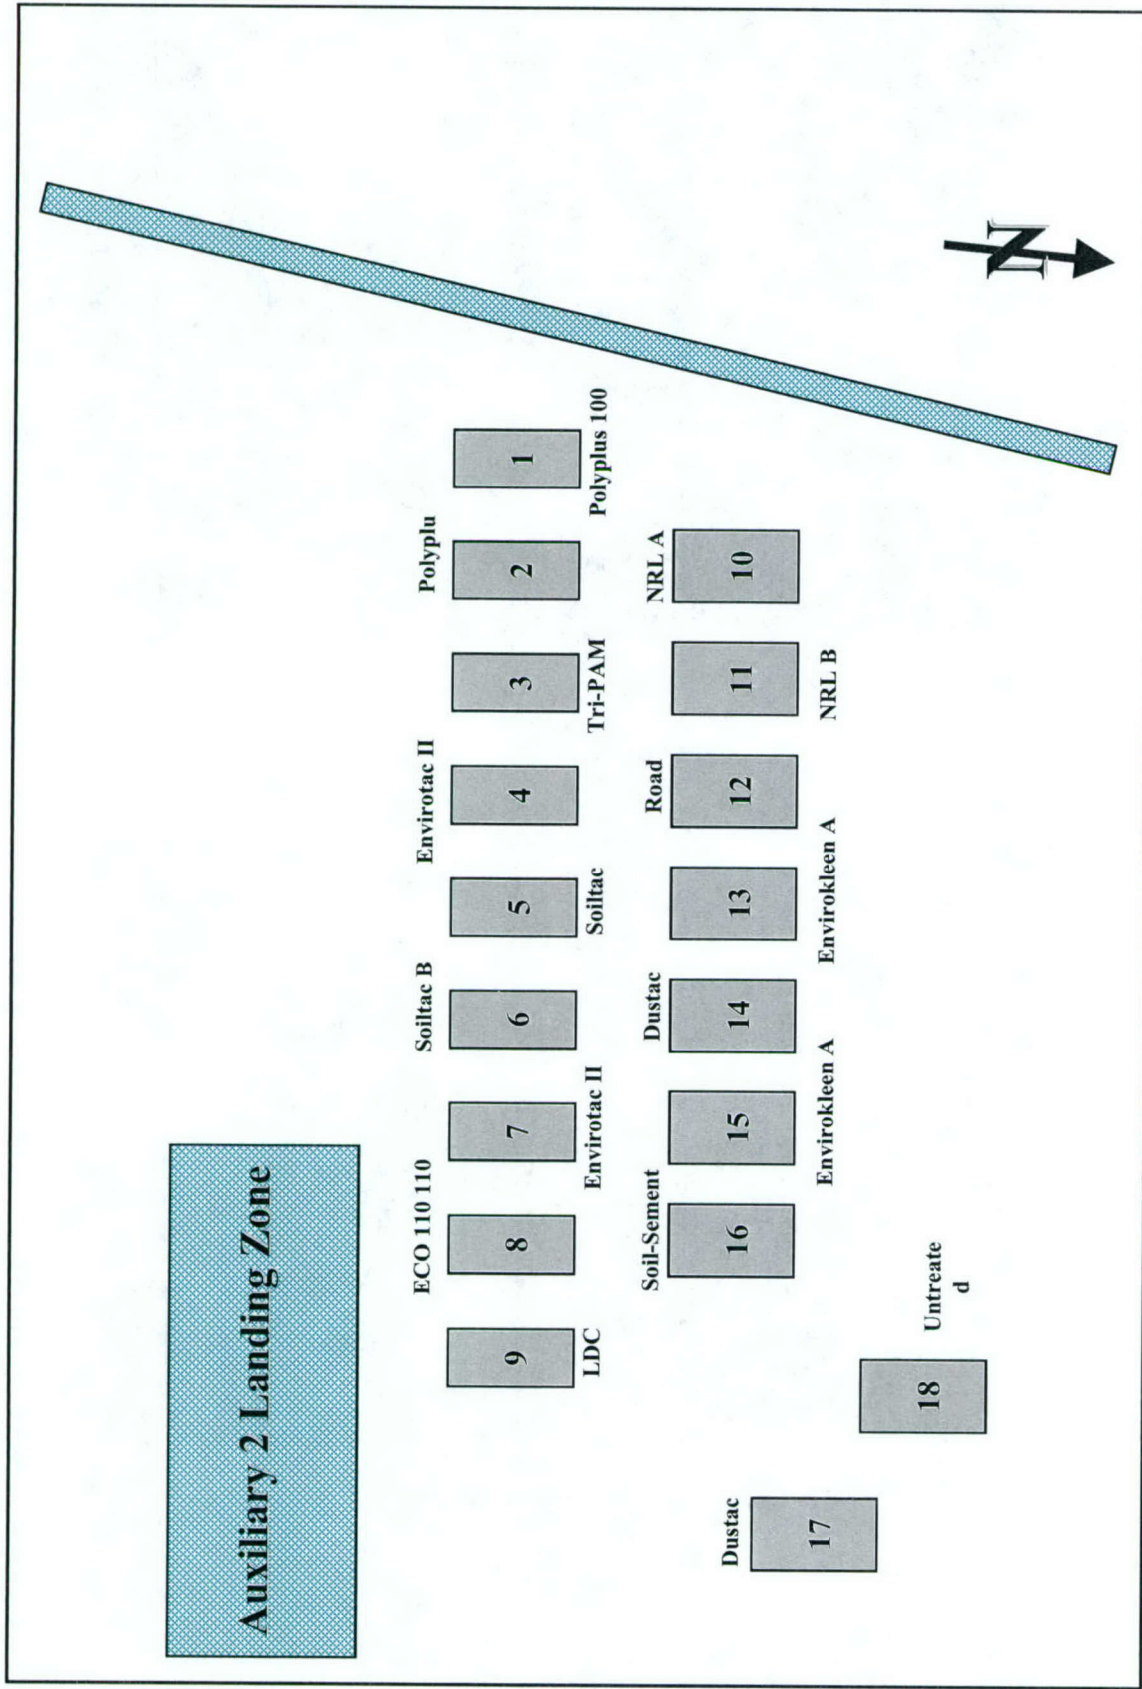
Figure 8. Dust abatement test site layout near Auxiliary 2 Landing Zone, MCAS Yuma

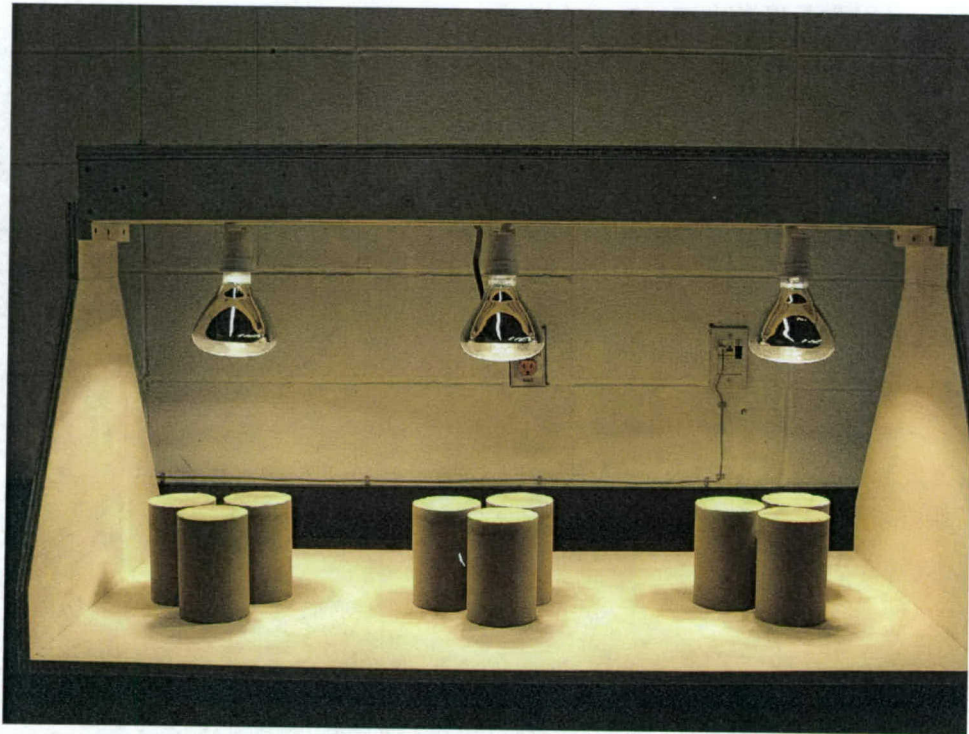
Photo 3. Laboratory curing of treated specimens simulating 120 °F

During previous investigations involving the evaluation of soil stabilization products, a rather simple and reproducible method of preparing laboratory specimens with chemical additives was developed (Santoni et al. 2002). For the initial laboratory evaluation of this program, a moisture content of 13 percent was selected in order to effectively mold the essentially cohesionless Yuma sand. However, for the polymer emulsions and lignosulfonates, a moisture content of 10 percent had to be used due to the lubricating effects of the materials in the sand and the shift of the moisture density curve to the dry side. At the target moisture content of 13 percent, pore water was exuded from the specimens during compaction. The Yuma sand was first oven dried to remove all moisture. Each palliative was then added in the desired concentration to 7000 g of Yuma sand and mixed thoroughly with an electric drill and rotary mixing bit (Photo 1). Any additional water needed to reach optimum moisture content was mixed into the sand prior to palliative addition. Once the sand, additive and water were thoroughly mixed, 2,200 g of treated material was weighed and placed into the mold. The cylindrical samples were compacted using a Pine® gyratory compaction machine using a 4-in.-diam mold at a ram pressure of 870 kPa and 90 revolutions in order to produce the same density as ASTM D 1557 (Photo 2). Three 4-in.-diam by 6-in.-high cylindrical specimens, each containing 2,200 g of treated soil, were made for each test. This method of sample preparation allowed for the rapid production of a large number of samples with consistent properties. After compaction, the samples were extruded from the mold, weighed, and immediately placed under curing lamps at 120 °F for 4 or 24 hr to simulate desert ground surface temperature conditions (Photo 3) and to investigate the effect of curing time on product effectiveness.

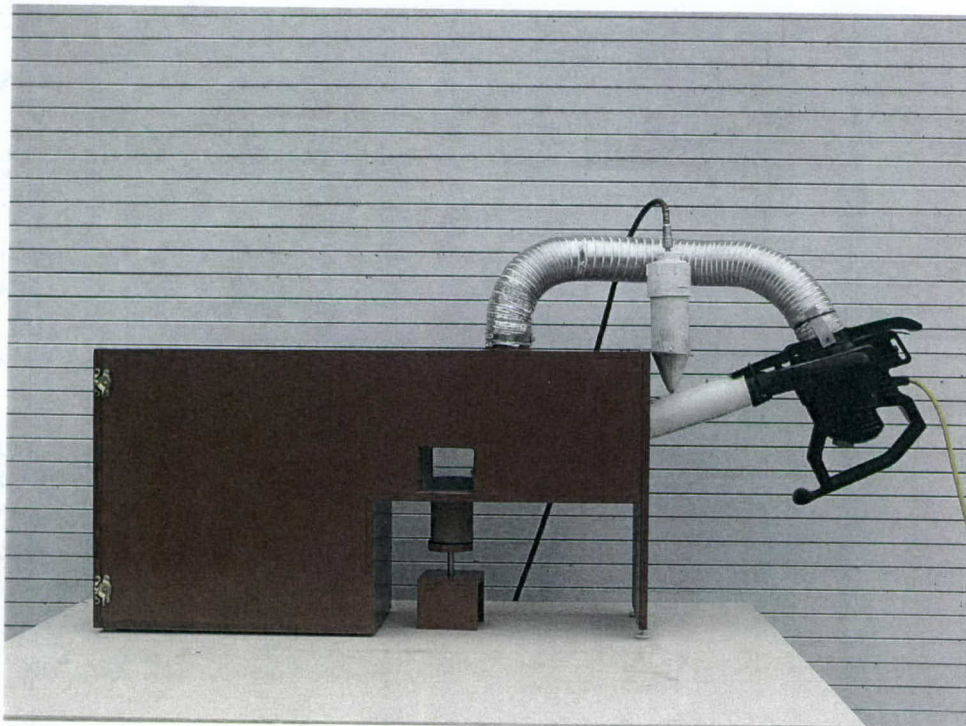
Photo 4. Laboratory air impingement device for simulating rotor wash

The air impingement device used in this evaluation is shown in Photo 4. The device generates wind velocities of up to 150 mph through an electric blower with a modified nozzle thermally cast from schedule 40, 3-in. PVC pipe. The pipe was molded to create a rectangular-shaped opening 4.50-in.-wide and 0.625-in.-high at the exit. The 150 mph wind speed was selected to simulate severe conditions created under an approaching helicopter. A 4-in. return flow duct circulates the air along with any suspended particles and relieves pressure in

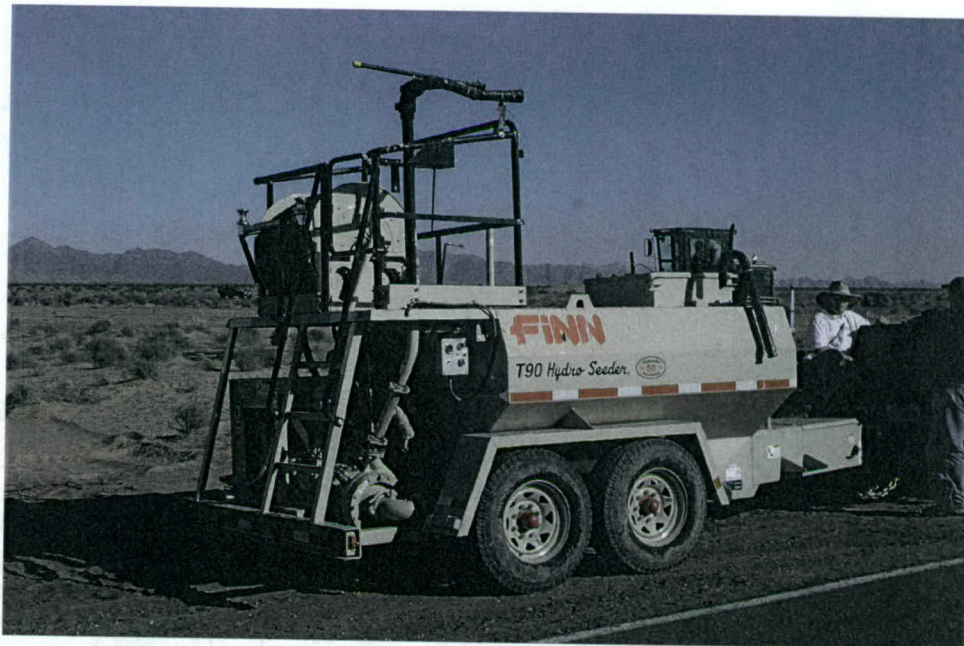
Photo 10. Finn T-90 hydroseeder

<b>Table 3</b> <b>T-90 Finn Hydroseeder Specifications</b>	
Tank	Metal with 940-gal capacity Mechanical agitator variable-speed reversible hydraulic motor Liquid recirculation
Engine	Diesel 4 cylinder water cooled, 33.5-hp, 15-gal fuel capacity
Pump	Centrifugal 4- by 2-in., 170 gpm at 100 psi Solid clearance adjustable, direct drive with center clutch
Tower Gun	Spray distance up to 180 ft Nozzles-Set of 4: 2 long distance, 1 wide fan, 1 narrow fan
Spray Hose	200 feet, 1-1/2 in. rubber Nozzles-Set of 3: 1 long distance, 1 wide fan, 1 narrow fan
Trailer	7,000-lb tandem axles, rubber torsion suspension, Electric brakes 12.4 cu ft storage box Highway tires: 9.5- by 16.5-in. tubeless, load range E
Hitch	Heavy-duty hitch eye or 2-5/16-in. ball Adjustable height: 12 to 23 in.; Weight: 1,900 lb
Empty Weight	5,420 lb
Working Weight	14,670 lb
Overall Dimensions:	Length - 16 ft 2 in.; Width - 7 ft 1 in.; Height - 9 ft (top of tower gun)

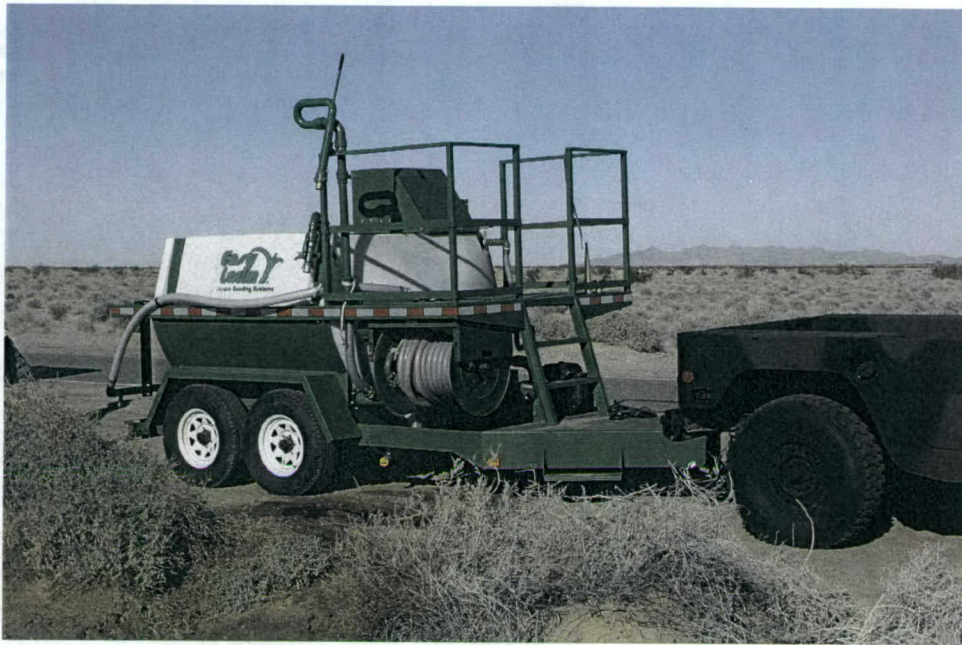
Photo 11. Easy Lawn L-90 hydroseeder

<b>Table 4</b> <b>L-90 Easy Lawn Hydroseeder Specifications</b>	
Tank	Plastic, 900-gal capacity Hydraulic Agitator/Recirculation Pipe
Engine	OHV V-Twin Electric Start, 25-hp Robin Subaru Fuel capacity – 16 gal
Pump	Centrifugal 4- by 3-in., 620 gpm max or 85 psi max, 75 psi operating pressure
Tower Gun	Spray distance up to 145 ft Nozzles-Set of 4: 2 long distance, 1 wide fan, 1 narrow fan
Spray Hose	100 ft Poly: 1.5-in.-diam Nozzles: variable up to 50 gpm at 40 psi
Trailer	6,000-lb tandem axles, spring suspension 7-cu ft storage box Tires – 16.5-in. tubeless with highway tread, load range E
Hitch	Heavy-duty hitch eye or 2-5/16-in. ball Adjustable height: 12 to 24 in.; Hitch weight: 900 lb
Empty Weight	4,700 lb
Working Weight	12,000 lb
Overall Dimensions	Length: 15 ft and 9 in. Width- 7 ft and 11.5 in. Height: 8 ft and 3 in. (top of tower gun)
Unit Cost	\$18,500
Point of Contact	Bob Lisle, Easy Lawn, Inc., 9599 Nanticoke Business Park Drive, Greenwood, DE 19950 1-800-638-1769 or 302-349-0800

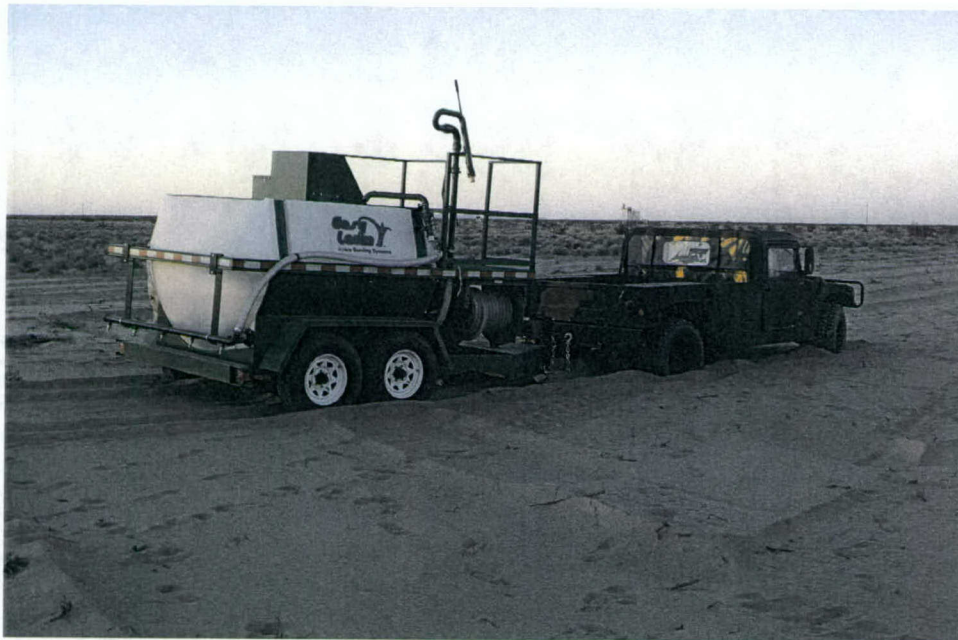
Photo 16. HMMWV and Easy Lawn hydroseeder immobilized in loose sand

The original plan was to tow the hydroseeders using a Marine Corps HMMWV vehicle. This vehicle proved to be inadequate due to the soft sands at the field site (Photo 16). Due to hitch height limitations on the hydroseeders, the HMMWV had to be used as the tow vehicle; therefore, an unloaded MTRV was used to tow both the HMMWV and each of the hydroseeders during the entire exercise (Photo 17). Both hydroseeders have three methods for applying dust control palliatives: a hose distributor, a tower gun, and a distributor bar (not on Finn model used). The distributor bar was not provided on the Finn model used and the bar on the Easy Lawn system was not used due to maneuverability issues in the soft sands.

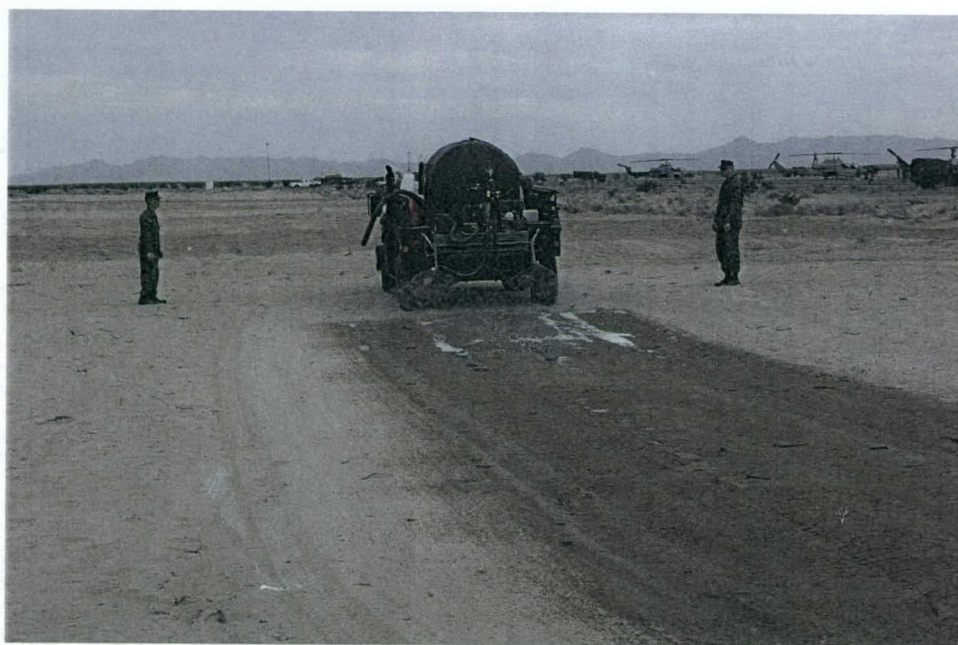
Photo 24. Application of water and PAM emulsion using the DAV system

- d. Once the dry material was scarified into the surface, approximately 1,650 to 2,000 gal of water combined with emulsified PAM was applied to the surface of the test area (Photo 24). A hand sprayer using a 1-in. hose was used to overspray areas that appeared to have inadequate emulsion coverage. Thus, the DAV system will require an additional water storage asset such as a water truck or an MTRV with at least three six-cons of water.
